*Information Updated  
9/23/11 nje*

**Confidential Inspection Report  
1572 Fulham Street, Falcon Heights**

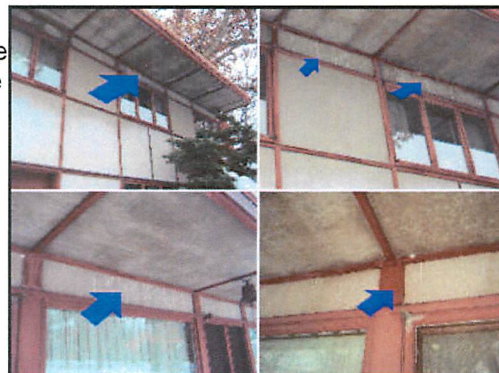
There is an area at the rear above the A/C compressor which is wet on the wall and the soffit underside. Unable to determine where this water is from, but it is possible that it is roof leakage. Recommend further evaluation by contractor to determine source of water. The front and rear above the upper windows have streaking on the siding indicating past leakage.

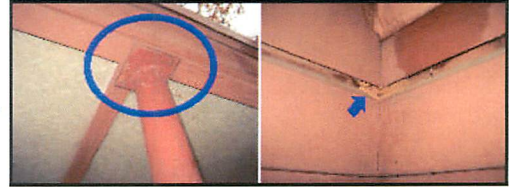
**Access:** The footings for the porch are primarily underground. No evaluation or determination of footing condition is performed during this inspection.

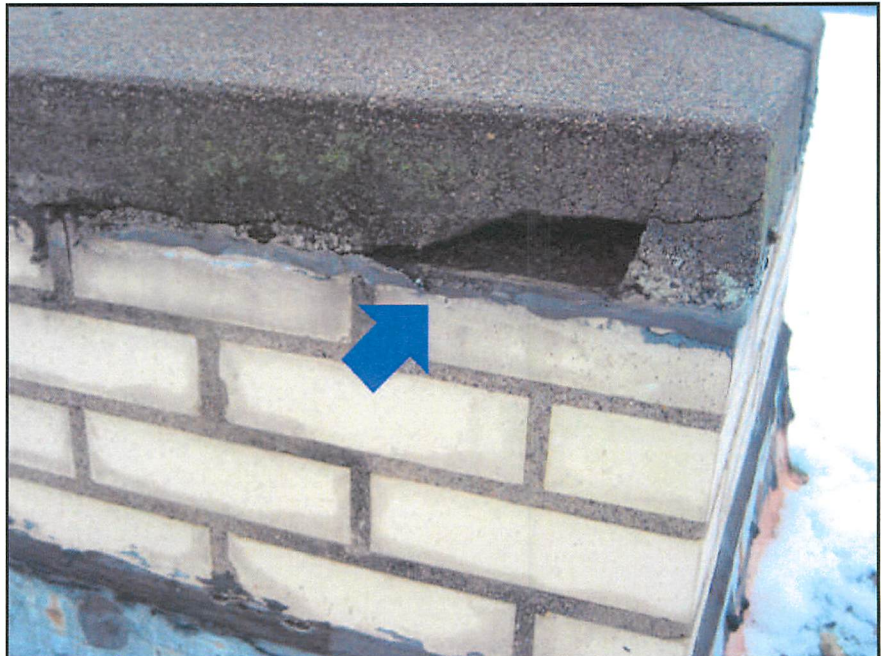
*Chimney cap repaired  
rain caps installed*

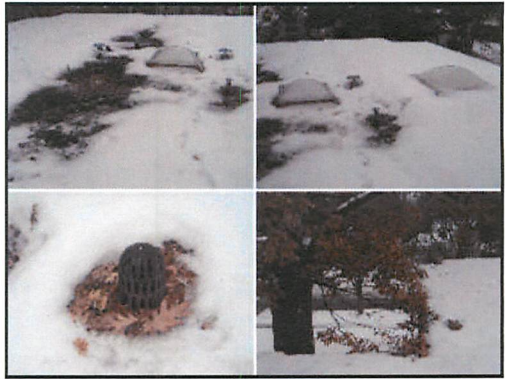
### EXPOSED FLASHINGS

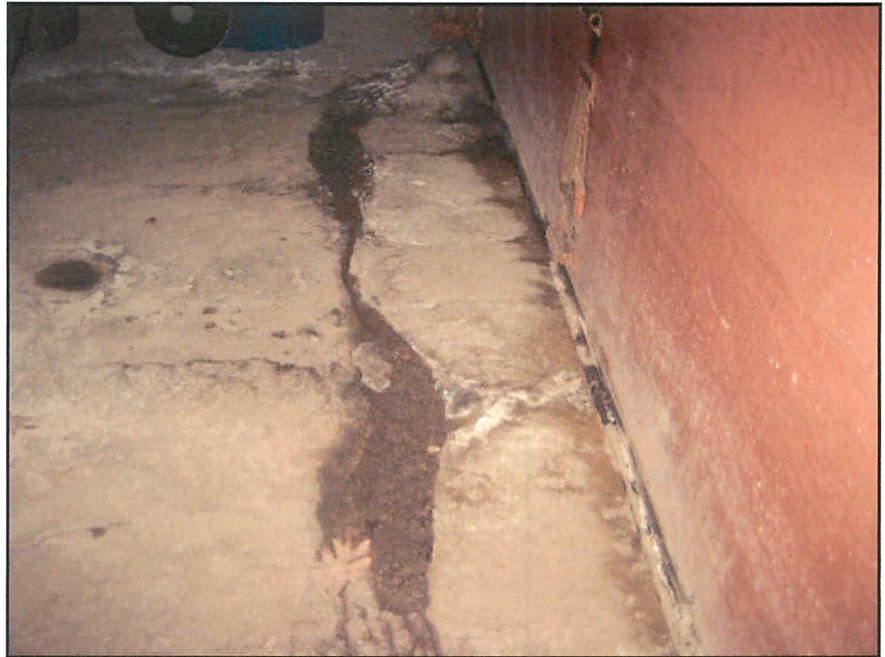
Cracks and deterioration by front of garage, repair recommended.

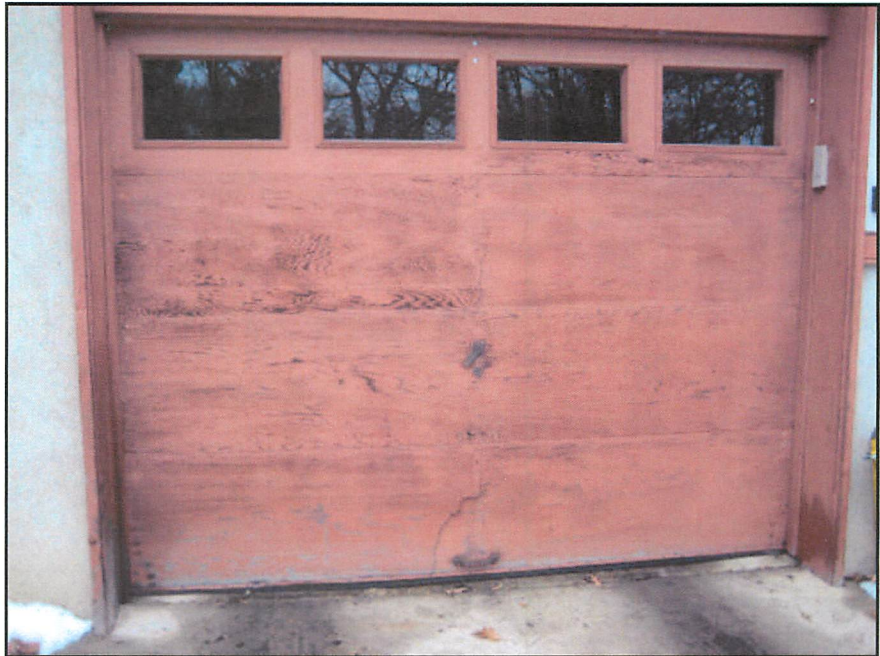
One door, Roll up. Roll up doors are the most common type. They travel on a metal track with counterbalance springs. Door is damaged, recommend replacement.

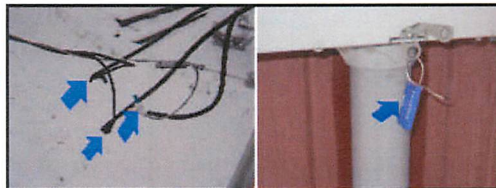
Type of Delivery: Overhead service wires, 110/220 Volt, the main panel/disconnect is located in the basement. There is a temporary connection at the service mast and the tamper seal is cut. Recommend obtaining final inspection by electrical inspector and having power company make proper connections at mast.

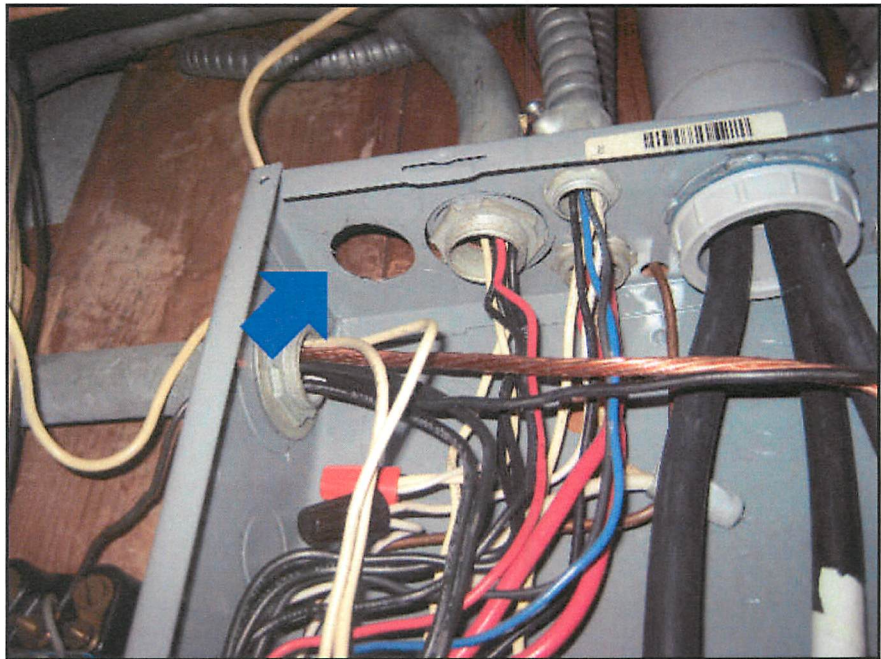
Knockout missing at top of panel. Have proper plugs installed to prevent contact with live electrical, or foreign objects from falling into panel.

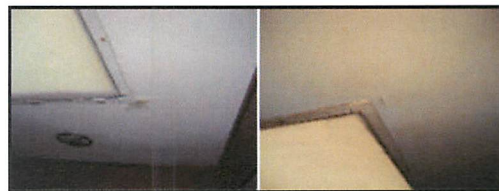
**Condition:** Moisture stains or other signs visible at the interior could be from interior moisture condensation or water leakage from the exterior. It is not known for certain which is the case. Request information regarding these signs from the seller.

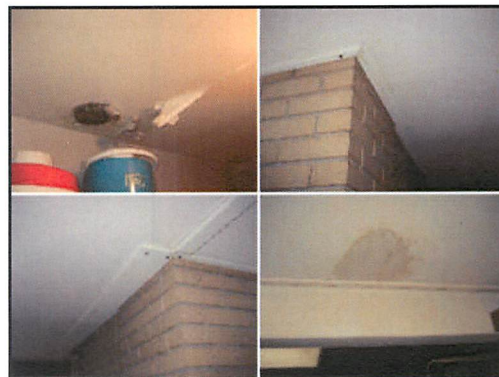
**Condition:** *repaired & repainted*  
*repaired & repainted*  
Stains around basement closet where the bottom of a plumbing drum trap is visible. Stains around chimney and by living room arch to office area indicating past leakage. Unable to determine if leaks are active. **No** Monitor. Potential for hidden moisture damage.

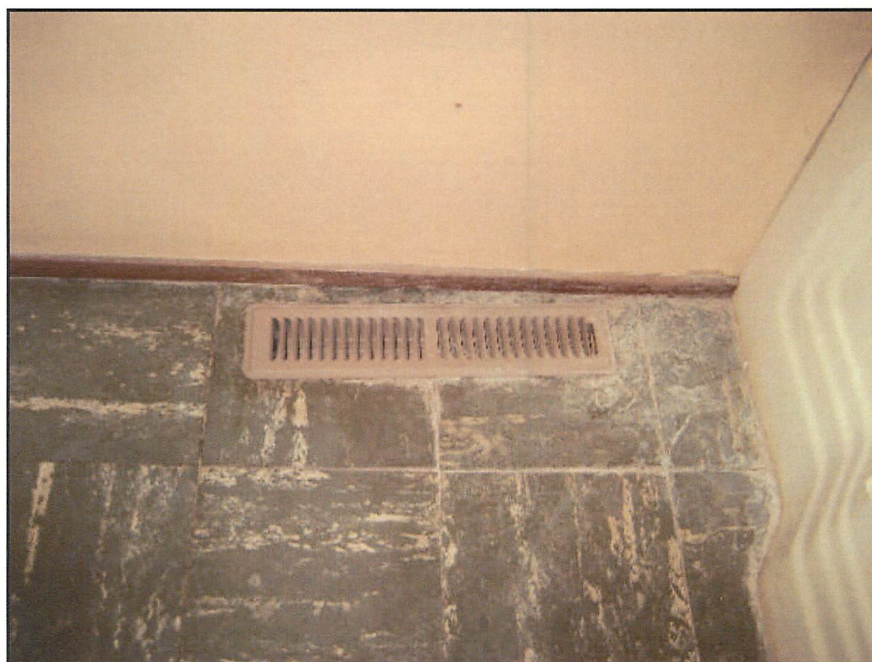
Staining on floor by tub and vent indicate past leakage. Water may have entered sub slab ductwork. See heating section.
